Subject: Tree Protection Plan for existing mature shade trees in median of Seis Lagos Trail

Site Review: April 23, 2025
Site: Seis Lagos Trail
Wylie, Texas 75098

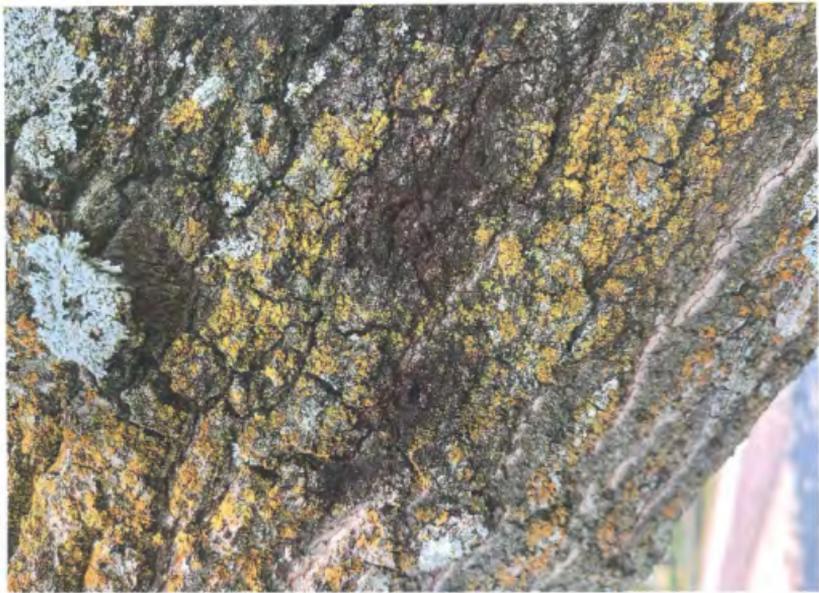
#2

DISTURBANCES	EFFECTED TREES (TAG # & PICTURE #)
Fungal Matte/Conks	Tag #713, 718, 727 & Pictures #3, 4
Bleeding	Tag #713, 718, 720, 727 & Pictures #2, 3, 17
Splitting/Freeze Damage	Tag #723, 724, 726
Mechanical Damage	Tag #706, 707, 710, 714, 716, 717, 718, 719, 720, 721, 725, 728, 729, 730, 734, 736 & Pictures #9-13
Girdling Roots	Tag #728, 729 & Pictures #4, 7
Cracks/Drought Damage	Tag #718, 720, 727
Sunscald	Tag #713, 718, 727

TAG #	# OF INCLUSIONS Pictures #1, 5, 6, 8, 15, 20-22	MISTLETOE Infestation(Light, Medium, Heavy) Pictures #2, 8, 14, 25	DEADWOOD (Light, Medium, Heavy) Pictures #3, 10, 16, 24
706	1	-	Light
707	-	-	Light
708	-	-	Light
709	-	-	Light
710	-	Medium-Heavy	Light
711	-	Medium-Heavy	Light
712	1	Light-Medium	Light
713	-	-	Heavy
714	-	-	Light
715	-	-	Light
716	1	Heavy	Light
717	-	-	Light
718	-	-	Medium
719	1	Heavy	Light
720	-	-	Medium
721	2	Light-Medium	Light
722	1	Light-Medium	Light
723	-	-	Light
724	-	-	Light
725	1	Medium-Heavy	Light

Our findings from the above tables are as follows. Deadwood is not only a physical threat to trees, for the free incursion of disease and boring insects, but also a liability to those who frequent underneath them. Mistletoe (*Viscum album*) is a parasitic plant that robs the host plant of resources even in the winter. Debilitating if not removed, will kill the tree (Pics.#1,8,14). The other structural issue that predominates these trees are trunk and limb inclusions that result in cracked split trunks (Pics.#1,4-6,15,21) and broken/torn limbs. Drastic measures such as cabling and bracing shall be taken to help hold trees with defects together. Pruning is often combined with cabling and bracing to minimize risk of tree failure. The 4 Red Oaks, already with numerous stresses (Pics.#2-3,16-19), would not be recommended for saving.
